DEPARTMENT OF TRANSPORTATION**DIVISION OF ENGINEERING SERVICES**

Quality Assurance and Source Inspection

Contract #: 04-0120F4Cty: SF/ALA Rte: 80 PM: 13.2/13.9File #: 69.28**WELDING INSPECTION REPORT****Resident Engineer:** Pursell, Gary**Address:** 333 Burma Road**City:** Oakland, CA 94607**Report No:** WIR-003132**Date Inspected:** 24-Jun-2008**Project Name:** SAS Superstructure**OSM Arrival Time:** 1400**Prime Contractor:** American Bridge/Fluor Enterprises, a JV**OSM Departure Time:** 2330**Contractor:** Zhenhua Port Machinery Company, Ltd (ZPMC), Changxing Island **Location:** Shanghai, China**CWI Name:** Sun Wei/Li Yanhua**CWI Present:** Yes No**Inspected CWI report:** Yes No N/A**Rod Oven in Use:** Yes No N/A**Electrode to specification:** Yes No N/A**Weld Procedures Followed:** Yes No N/A**Qualified Welders:** Yes No N/A**Verified Joint Fit-up:** Yes No N/A**Approved Drawings:** Yes No N/A**Approved WPS:** Yes No N/A**Delayed / Cancelled:** Yes No N/A**Bridge No:** 34-0006**Component:** OBG**Summary of Items Observed:**

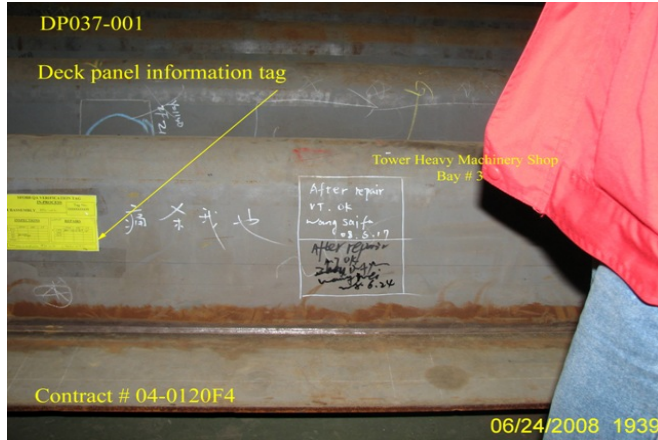
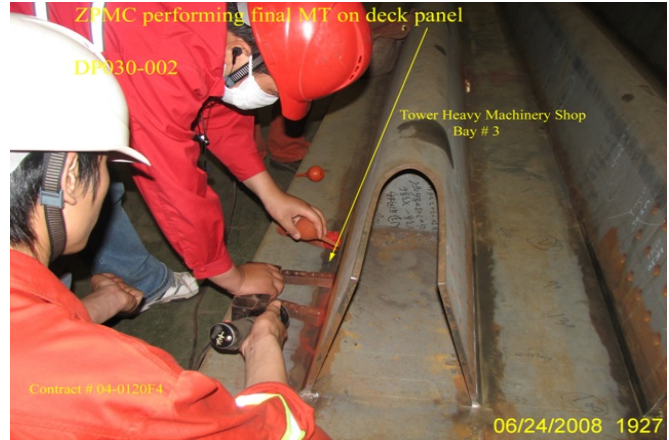
The QA Inspector Dixon was informed by ZPMC QC Inspector Mr. Zhang Jiadi that ZPMC CWI Inspector CWI Li Yanhua, and Sun Wei and ABF personnel were about to perform an R2 visual repair inspection on deck panel DP037-001 and requested that a Caltrans QA Inspector also performed a visual inspection on the deck panel.

After an agreement was reached by all parties for the repairs which needed to be made on the deck panel the QA Inspector identified the repairs to be completed as R2 inspections by marking the yellow tag which is pasted to the outside U-Ribs on the deck panel.

The QA Inspector observed ZPMC perform the final Magnetic particle Testing (MT) and a final visual inspection on deck panel DP030-002.

The deck panel repair welding in the progress generally appeared to conform to contract specifications.
